# Aldersgate Energy Improvement Project 2019

## A Pictorial History

### December 2019

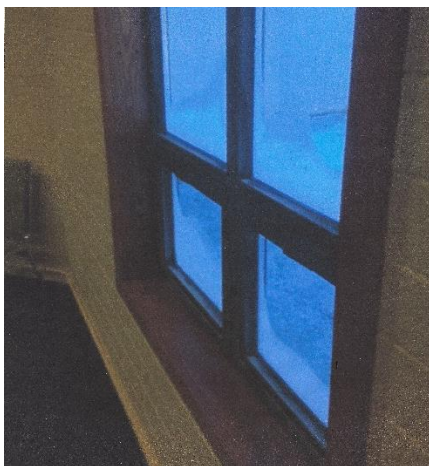
The pictures, below show frost on the old window (left), the outside concrete wall with a PTAC unit (middle), and concrete construction of the exterior walls with no insulation (right).

- Replace two large windows in Room 4 that had uninsulated metal frames and failing seals. The new windows include a thermal break in the frame, insulation in the metal frame, and eliminate the moveable window sashes.
- Replace two old PTAC HVAC units (the type common in motels) in Room 4 and an electric resistance heater in the women's restroom. The new system is a high efficiency split system heat pump.
- Address the lack of insulation (other than vermiculite in the voids) of the concrete walls. The solution provided 2" of insulation as part of an EIFS (Exterior Insulation and Finish System).
